TECHNICAL NOTE

No. 1427

LABORATORY INVESTIGATION OF ICE FORMATION AND ELIMINATION IN THE INDUCTION SYSTEM OF A LARGE TWIN-ENGINE CARGO AIRCRAFT

By Willard D. Coles

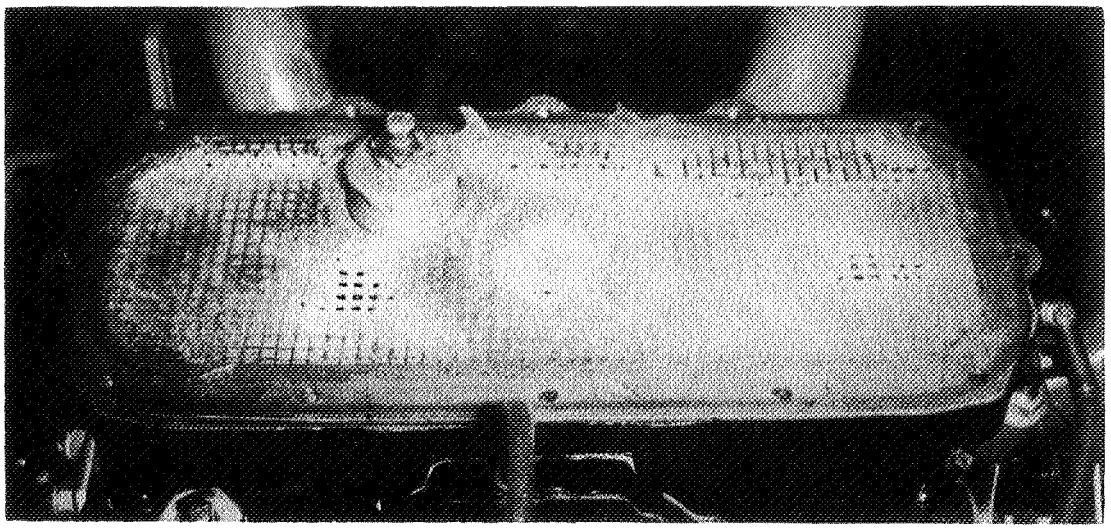
flat and fits very closely to the boost venturi, became iced (fig. 5(a)) to the extent that air flow was reduced 50 percent in 6 minutes at a carburetor-air temperature of 28° F with a water-injection rate of 500 grams per minute (humidity ratio, 0.0136). When such icing occurs, the metering of the carburetor can be impaired without any ice forming on the air-metering parts because of reduced air flow through the boost venturi. Water passing through the screen before it is blocked with ice causes ice formation on the venturi, boost venturi, and impact tubes (fig. 5(b)) and results in excessively rich or lean mixtures dependent upon the principal location of the ice.

(a) Screen icing.

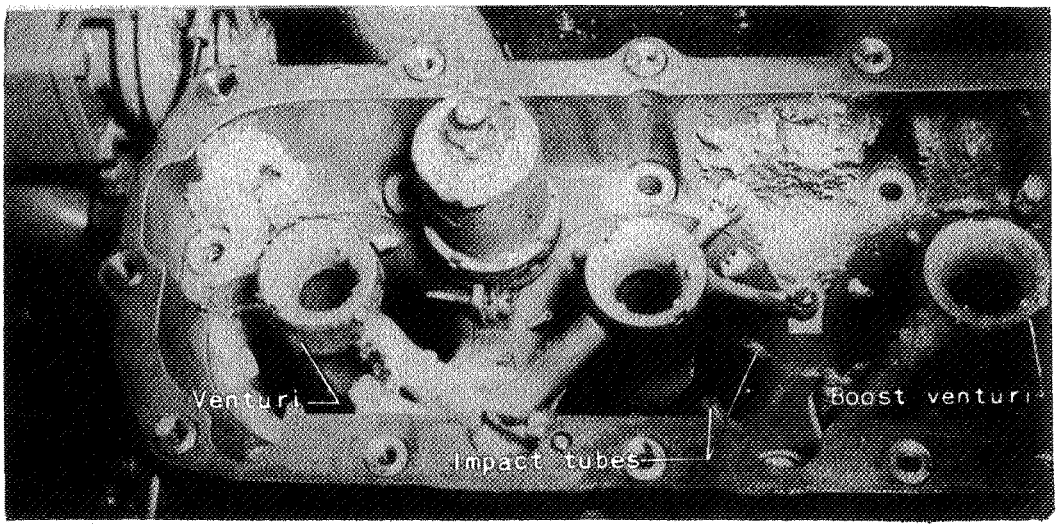
(b) Venturi, boost-venturi, and impact-tube icing.

Figure 5. - Impact-ice formations on carburetor screen and carburetor top deck.

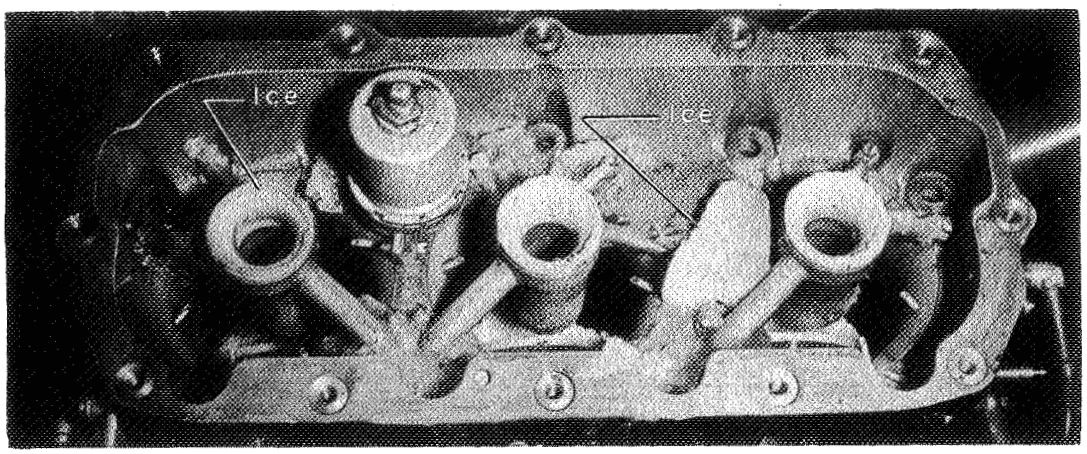
Under very light impact-icing conditions at a temperature of 29° F when the carburetor-entrance screen was not used, little ice formed on the carburetor (fig. 7(a)), a heavy deposit formed on the throttle plates (fig. 7(b)), and a trace of ice was observed on the top inlet-guide vane at the supercharger-impeller entrance (fig. 7(c)). This ice did not seriously affect operation during a 3-hour run; the top guide vane makes poor thermal contact with the warm walls of the inlet elbow and is the location most susceptible to ice formation below the carburetor. (See fig. 7(c).)

(a) Carburetor top deck.

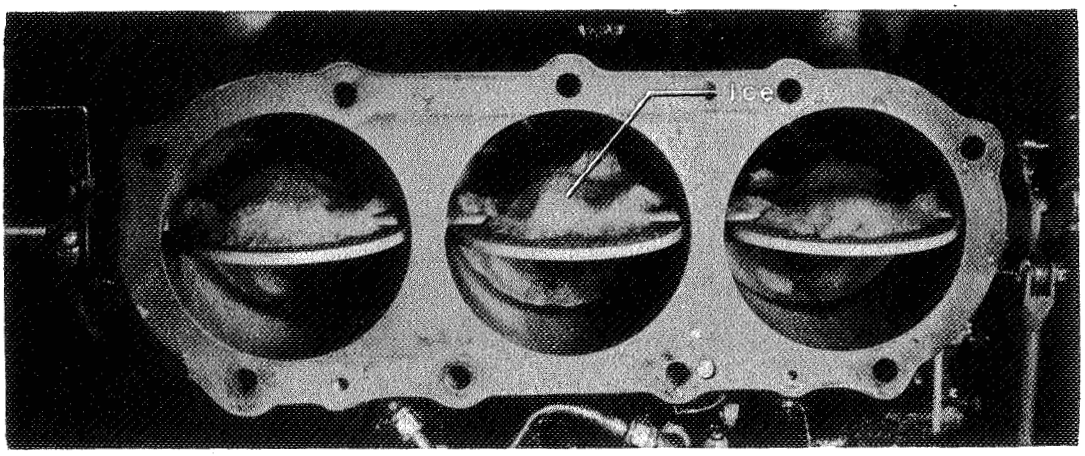
(b) Throttle plates.

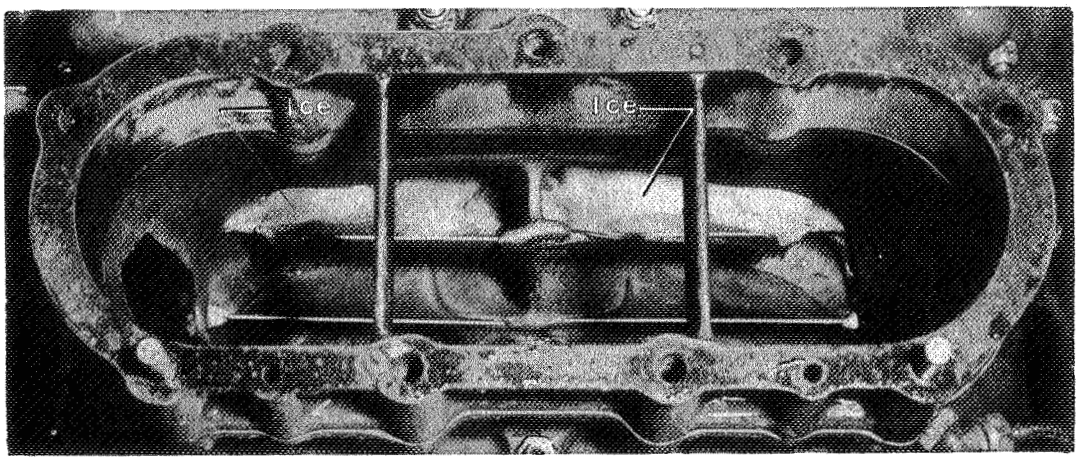
(c) Supercharger-impeller entrance vanes.

Figure 7. - Impact-ice formation on carburetor and supercharger turning vanes after 3 hours of icing.
